Assessment of conventional French railway sub-structure: a case study

Trong Vinh Duong, Yu-Jun Cui, Anh Minh A.M. Tang, Nicolas Calon, Alain
Robinet

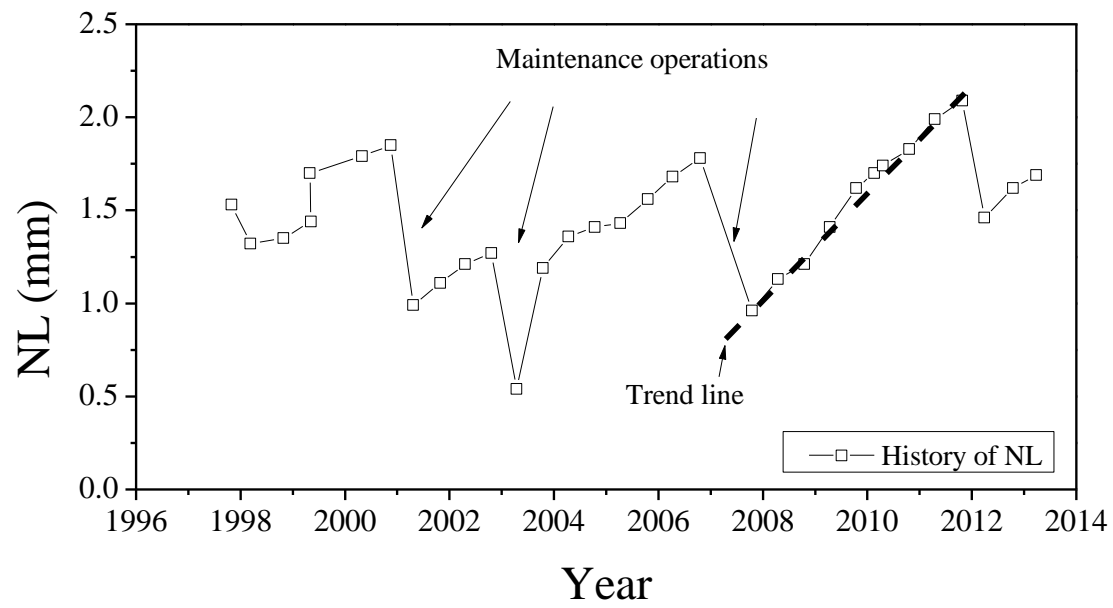
Fig. 9: History of *NL* variations for a given kilometer, with maintenance operation

Fig. 9 presents the variations of NL at kilometer 70.3 of Track 2 from 1997 to 2013. It can be observed that the value of NL decreased sharply after each maintenance (in the year of 2001, 2003, 2007 and 2012). However, after the maintenance, the value of NL continued to increase at almost the same rate: a linear increase trend of NL over time can be identified. It is worth noting that the slope represents the increase rate of NL or the degradation rate of tracks. The increase trend of NL persisted after a maintenance, suggesting that ballast replacement did not resolve the problem, and the track degradation was rather related to the sub-structure.

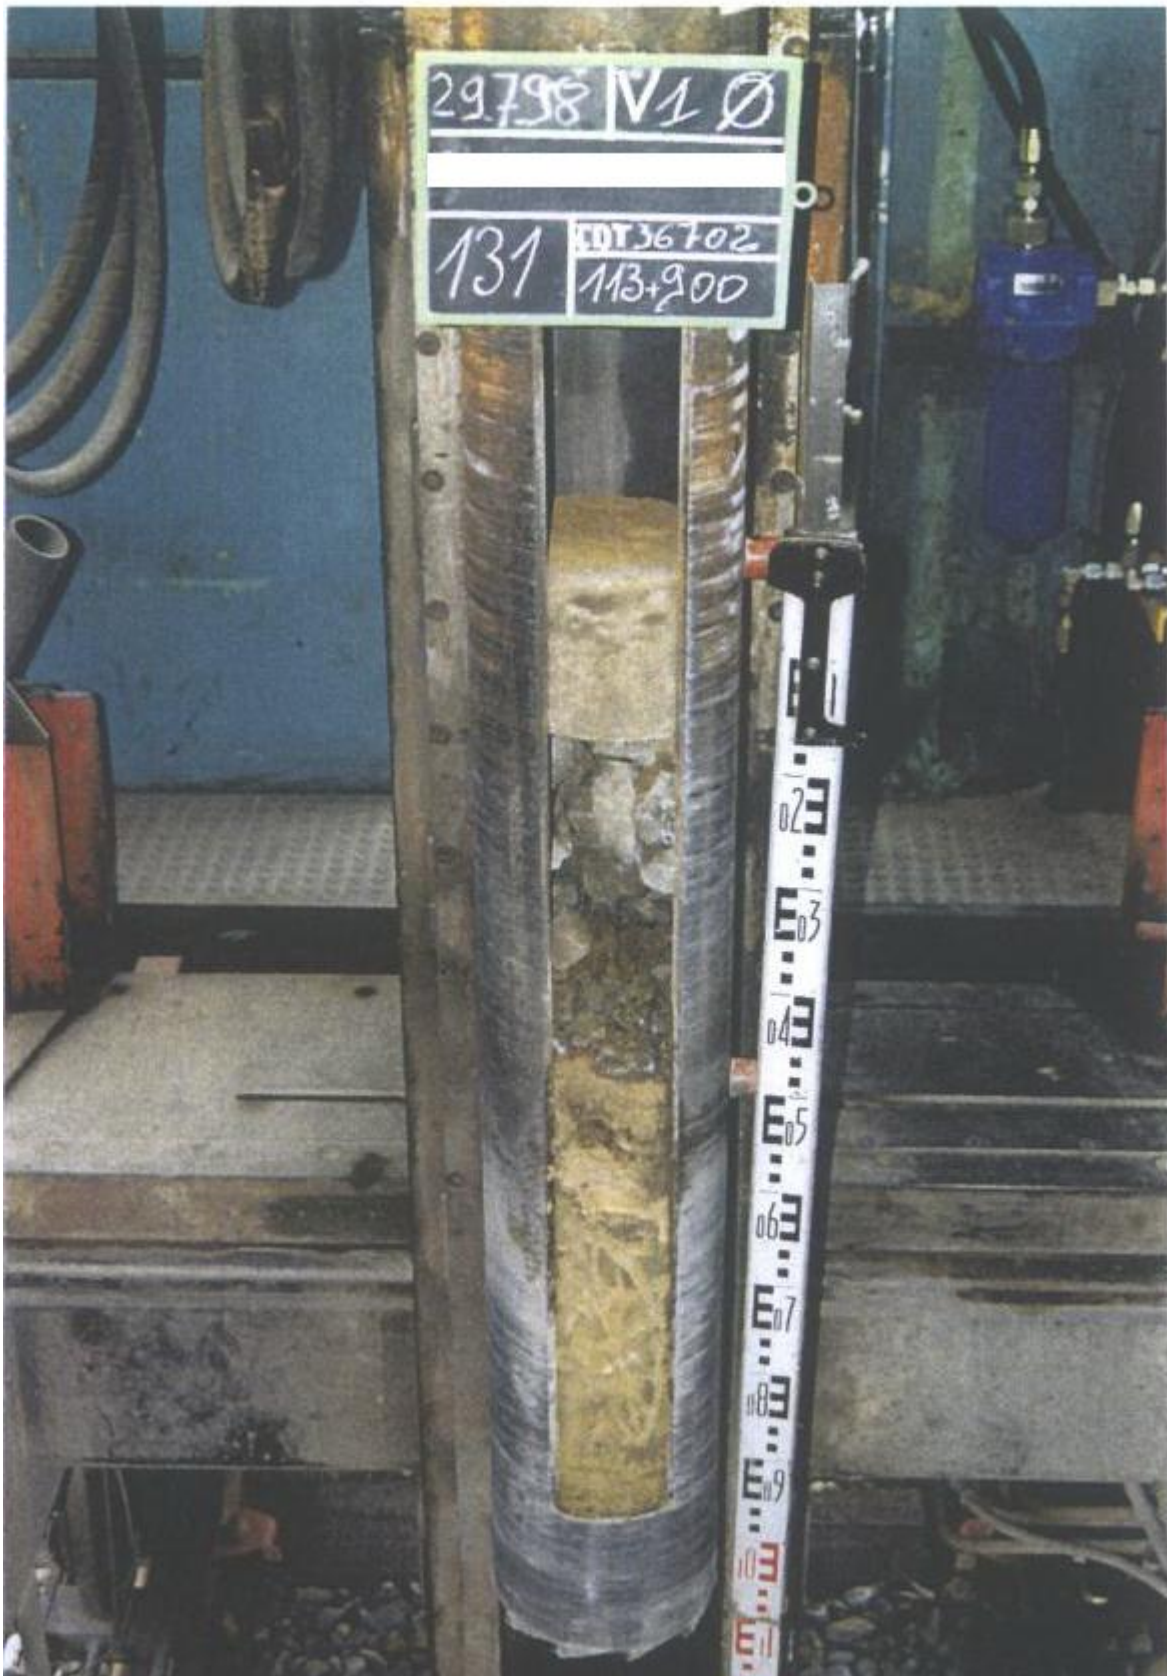
Fig. 10: Core sample from typical conventional railway sub-structure

The core sampler train is a special train which has the function as indicated by its name (SNCF 2011). The train was equipped with drilling equipment. Sample tubes are driven dynamically into track-bed to obtain a continuous core sample composed of ballast and underlying formations (Fig. 10). A digital camera is used taking photographs of the sample. From the photograph (see Fig. 10), the thickness of

each layer is analyzed and recorded. It can be seen that a typical track-bed consists of a clean ballast layer underlying fouled ballast layer and/or interlayer and sub-grade soil. The sample tube allows core sample to be taken till a depth of about 1.50 m. This depth is enough for identifying the different layers in the conventional railway track-beds. This investigation method was also reported in Brough et al. (2003; 2006).

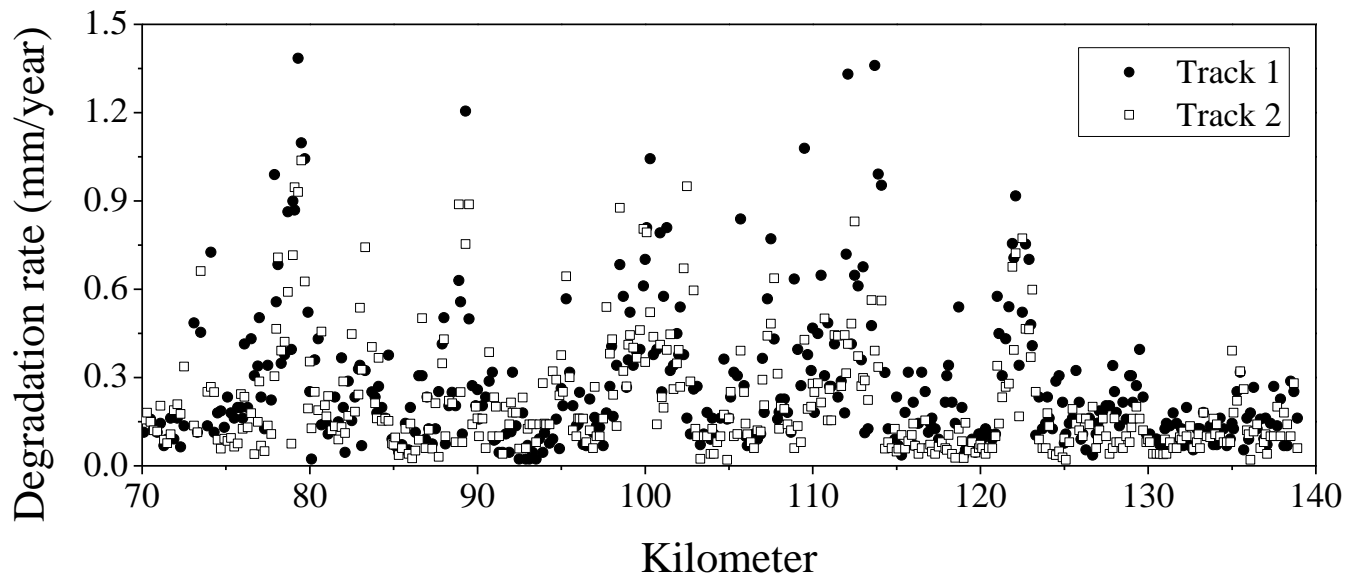
Fig. 12: Degradation rate along the studied line

Fig. 12 depicts the degradation rate (the increase of NL per year which was calculated from the slope as presented in Fig. 9) versus the kilometer point for Track 1 and Track 2. On the whole, there is an agreement between the data of two tracks; the peaks of Track 1 appeared almost at the same kilometer points as the peaks of Track 2.

From Fig. 12, the zones with high degradation rates can be identified. They are around PK 73, 79, 88, from 99 to 103, from 106 to 114 and 122. Referring to the geological information, it can be concluded that these kilometer points correspond to the zones where sub-grades contains large fraction of fine particles. Around PK 73, the sub-grade is rather argillaceous limestone and marl. Around PK 79, the sub-grade is fine alluvial deposits and peat. From PK 88 to 89, it is the alluvial deposits overlying the

argillaceous limestone or marl or peat. From PK 98-103, the sub-grade involves argillaceous limestone, marl and fine limestone. Around PK 113, the sub-grade contains sometimes colluviums. It is important to note that these soils are sensitive to changes in water content and train loading. Soils like peat, alluvial deposit and colluviums are very compressible and do not have the required mechanical properties for sustaining the train-induced load. This can explain the high increase rate of *NL* in these zones. From PK 123 to the end of the line, the increase rate of *NL* became low along the line, indicating a good performance of the tracks. This can be also explained by the sub-grade nature: hard limestone is involved along this section. For the first part of the line (up to PK 103), the sub-grade soils are quite variable. These changes in soil natures are also detrimental to the track performance.

From the analysis above, it can be seen that the sub-grade has a significant influence on the performance of railway structure. From a practical point of view, the zones with a sub-grade of low mechanical properties are not apt to become the foundation of railway sub-structure. If it is inevitable, improvement must be conducted in order to meet the requirements, such as a good drainage system or some soil improvements.

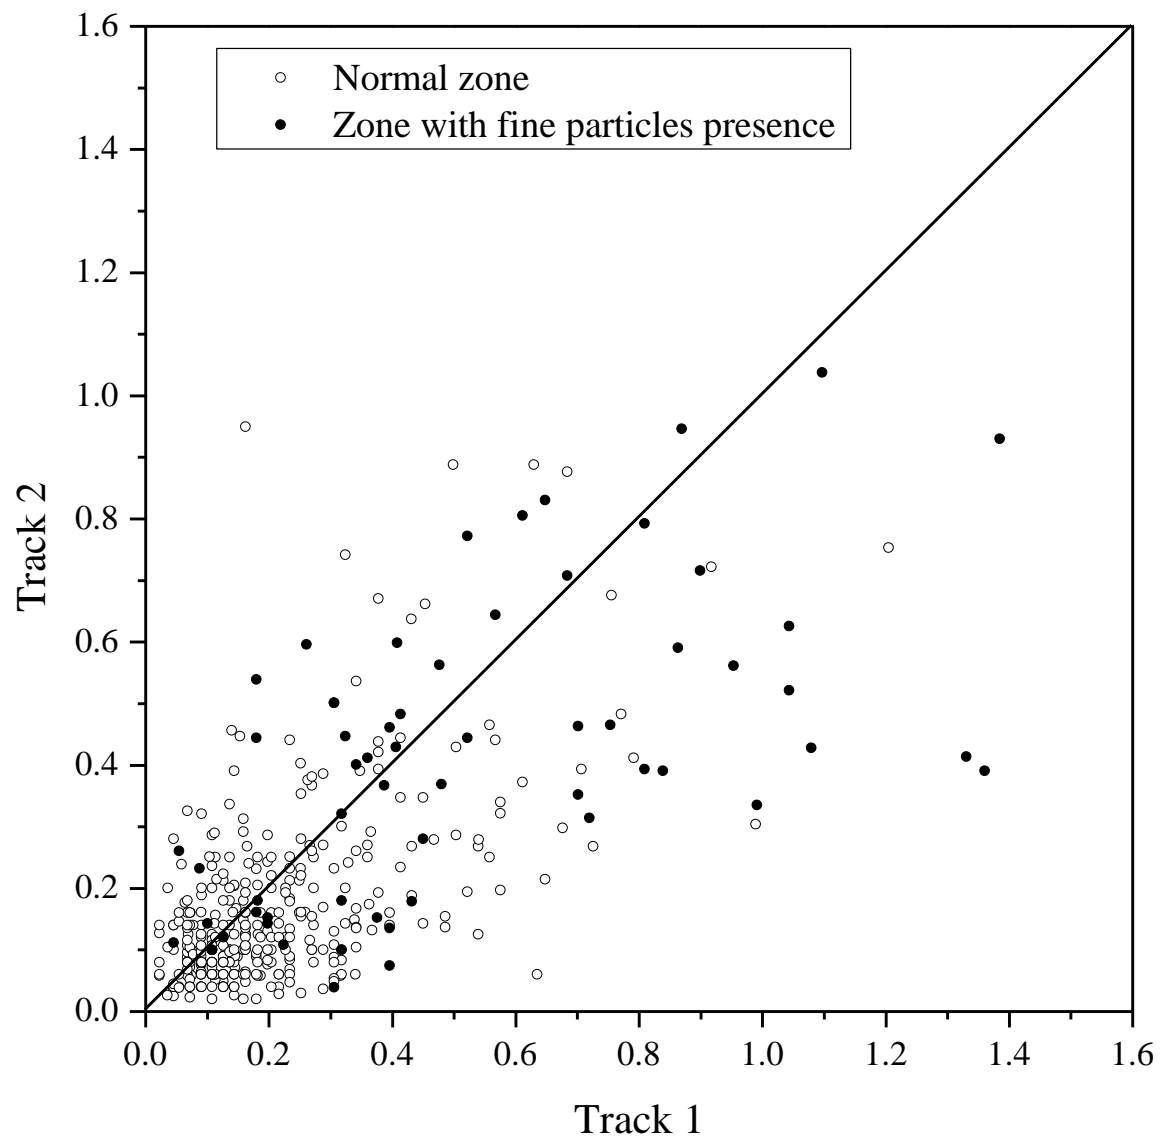
Fig. 15: Correlation between degradation rate of Track 1 and Track 2

Fig. 15 presents the correlation between the degradation rates of Track 1 and Track 2. It is observed that the *NL* of Track 1 increased more quickly than that of Track 2, because more data fall below the equality line. This is in agreement with the finding in the first part of work where the number of sub-structure related problems were recorded (Fig. 4). It is normally admitted that the train heading to the center (up line) carrying more freights and passengers than the train leaving the center (down line). More studies are needed to clarify this observation.

During the assessment of the whole line, the zones where fine particles were found on the ballast layer surface were identified. The degradation rates of these zones are presented in Fig. 15 with the black symbols. It can be seen that most of the zones with the presence of fine particles correspond to the zones

with high increase rate of NL . These fine particles came probably from the sub-grade when mud pumping occurred. This implies that the sub-grade containing large fraction of fine particles is detrimental to the performance of sub-structure. Indeed, for this kind of sub-grade soils, a decrease of mechanical performance can be expected when the moisture content rises. It appears thereby important to further investigate the effect of water content of sub-soil having large fine particles fraction and also the mud-pumping phenomenon.

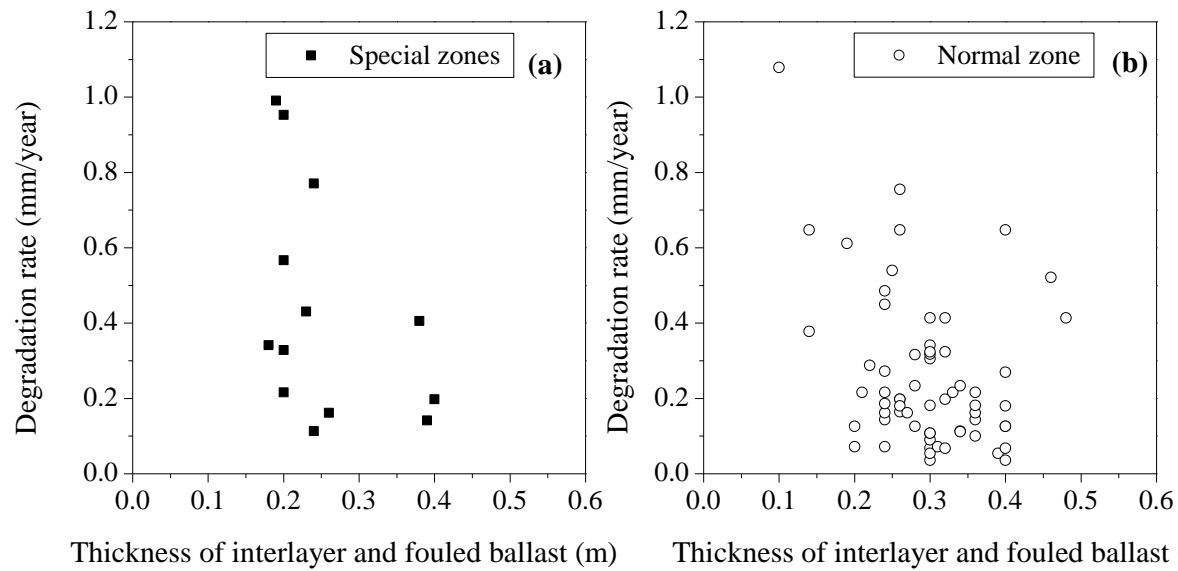
Fig. 16: Correlation of the degradation rate to the thickness of interlayer and fouled ballast for Track 1- Data from coring train. a) special zones and b) normal zone

Fig. 16 presents the correlation between the thickness of fouled ballast and interlayer (e) and the increase rate of NL for special zones (Fig. a) and normal zones (Fig. b), for Track 1. The same correlation is presented in Fig. 17 for Track 2. The special zones correspond to the zone of stations, the zones with bridges or viaducts. The other zones are referred to normal zones. For the special zones, Track 1 (Fig. 16a) presents a sharp decrease trend of degradation rate with the increase of e , while this trend is not observed for Track 2 (Fig. 17a). For the normal zones, despite the data scatter that can be explained by the presence of fouled ballast taken into account in the study, both Track 1 (Fig. 16a) and Track 2 (Fig. 17a) present a decrease of degradation rate as the layers thickness increases. As mentioned before, in the sub-structure of new lines for high speed train, there are a number of layers protecting more or less the sub-grade. On the contrary, in the sub-structure of conventional lines with the absence of an appropriate transition layer such as the sub-ballast layer, significant stress can be exerted to sub-grade soils, leading to significant deformation of tracks or degradation of tracks. The presence of interlayer somehow plays the role of a transition layer to reduce the stress applied to sub-grade. This explains the decrease trend of the degradation rate with the increase of e .

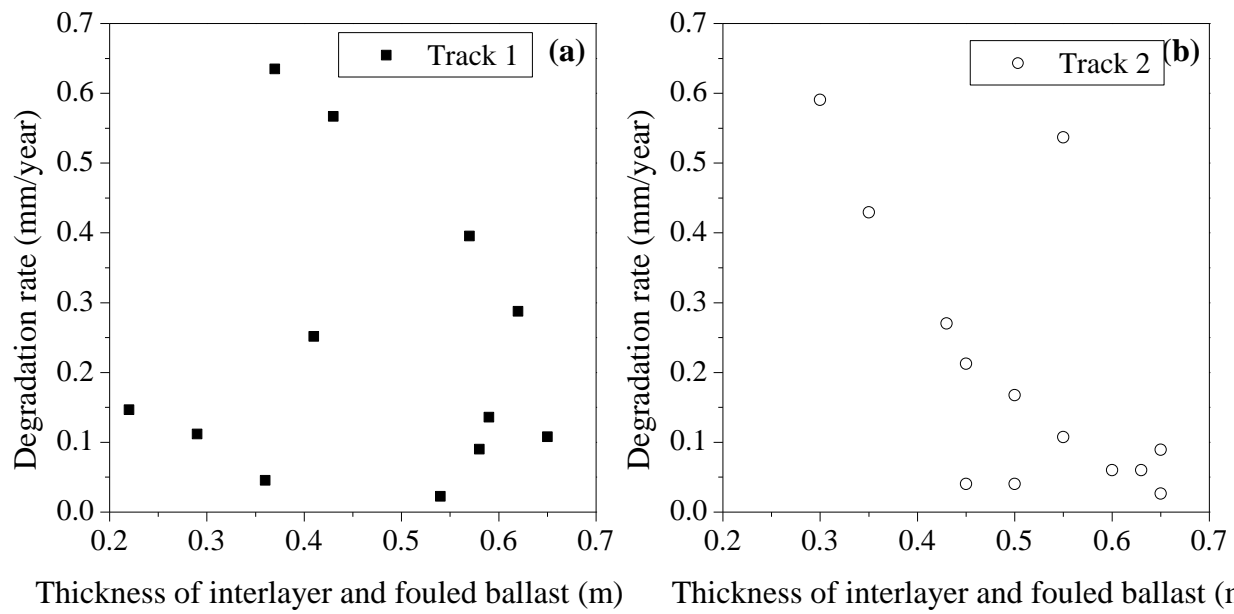
Fig. 18: Correlation of the degradation rate to the thickness of interlayer and fouled ballast - Data from Panda and Endoscope. a) Track 1 and b) Track 2

This trend is also observed in Fig. 18 where the layer thickness deduced from Panda penetrometer tests and endoscope observation is used. The trend is not clear for Track 1 but very clear for Track 2. This confirms the positive impact of interlayer in reducing the degradation of tracks with the increase of interlayer thickness. Note that in other countries, the presence of some layers such as capping
