Assessment of conventional French railway sub-structure: a case study

Trong Vinh Duong, Yu-Jun Cui, Anh Minh A.M. Tang, Nicolas Calon, Alain
Robinet

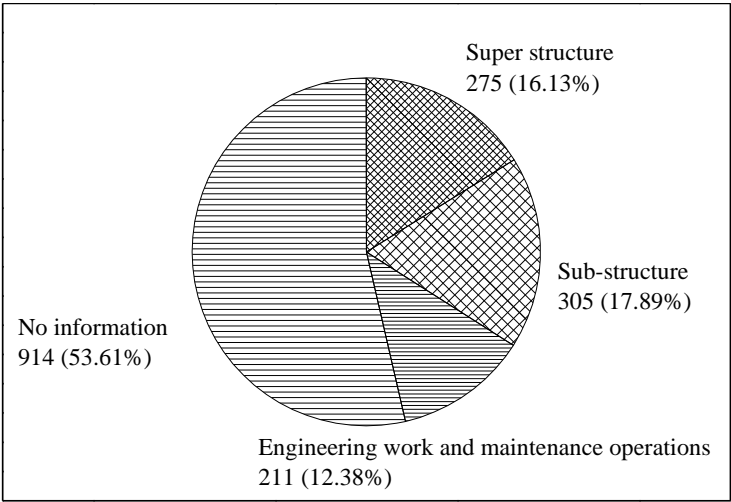
The problems related to train circulation (for instance, forced speed reduction in order to ensure the comfort of passengers) were recorded in the French railway network from January 2010 to May 2011. A total of 1705 cases was involved (Calon 2010). It was found that the causes can come from every track components (steel rail, fastening system, sleeper, ballast, sub-ballast and sub-grade). Four main groups can be defined as presented in Fig. 1, in relation to super-structure; sub-structure; speed reduction due to maintenance/engineering works and “no information” meaning that the cause has not been explicitly

433 **Fig. 1: Cause of the problems for the deceleration of train**

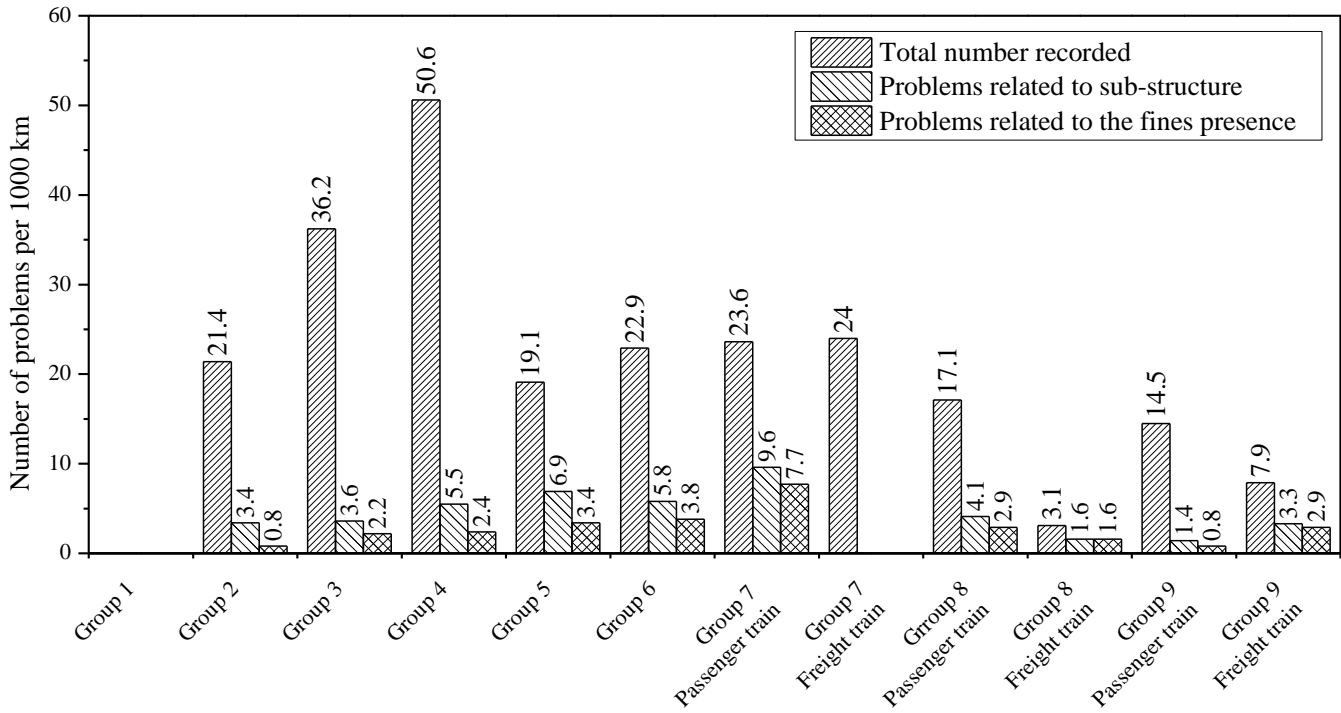
As the total length of each group is not the same (Table 1), it appears necessary to normalize the number of problems with respect to the length. The number of recorded problems per 1000 km of each UIC group was then determined and the result is presented in Fig. 2. The first category corresponds to the whole data recorded involving the problems related to all track components; the second category corresponds to the sub-structure-related problems. The third category involves the sensitive zones. It is observed that in the first category, the number of problems is indeed larger for the groups 2 to 4. It is group 4 that gathered the most part of problems.

435 **Fig. 2: Number of problems versus group UIC**

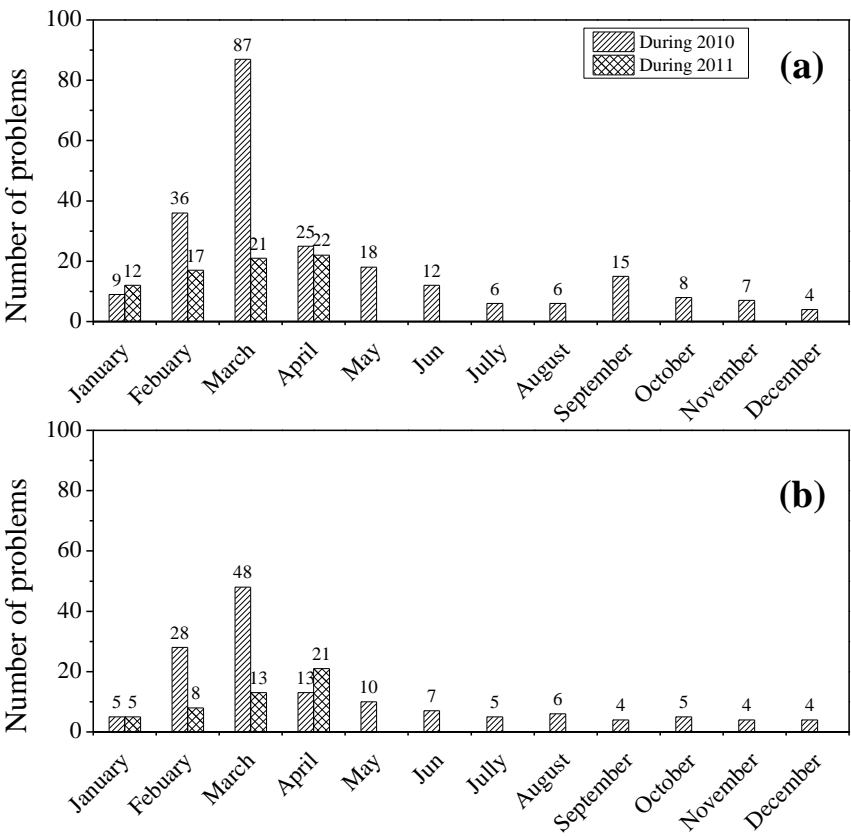
Problems occurred over a year are presented in Fig. 3a for the sub-structure and in Fig. 3b specifically for the clayey sub-soils (sensitive zones). Very often, the mud pumping phenomenon occurs in the

Fig. 3: Problems occurring over one year. a) Problems related to the substructure and b) problems related to the sensitive zones

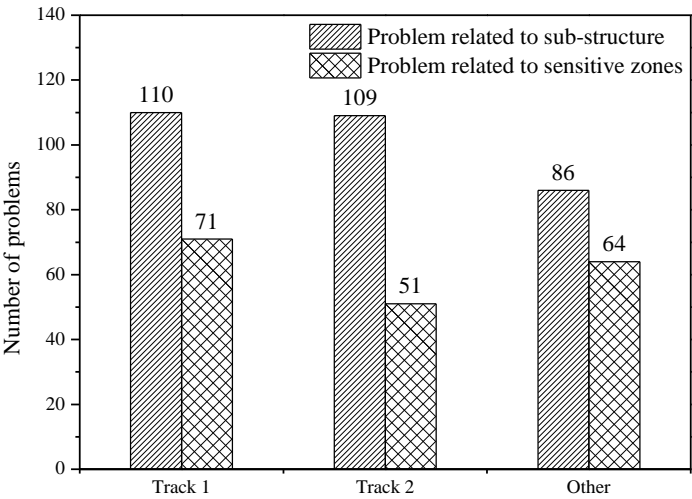
Fig. 4 presents the data recorded versus the type of tracks. Track 1 corresponds to the down line, Track 2 corresponds to the up line and “Other” corresponds to the single track line or secondary tracks. In the case of sub-structure-related problems, the number for Track 1 (110 cases) is equal to that for Track 2 (109 cases), while in the case of sensitive zones-related problems, the number for Track 1 (71 cases) is clearly larger than that for Track 2 (51 cases). Note that the drainage condition and the traffic for the Track 1 and Track 2 are not always the same. As the quality of the drainage system is not always the same, the water content can be different, hence different mechanical behaviors of soils can be expected for the two tracks since water content is one of the key parameters governing the behavior of railway sub-structure (Duong et al. 2013b).

Fig. 4: Problems recorded versus type of track

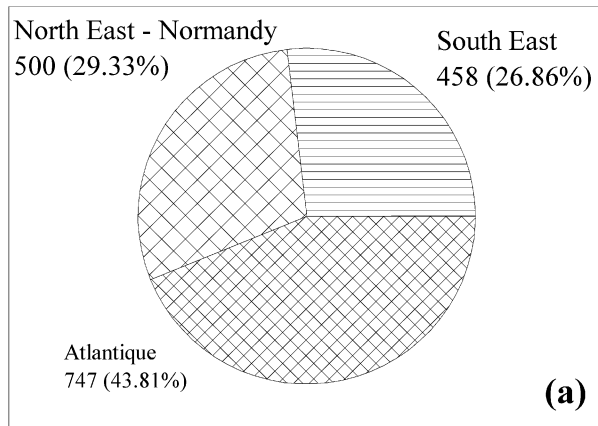
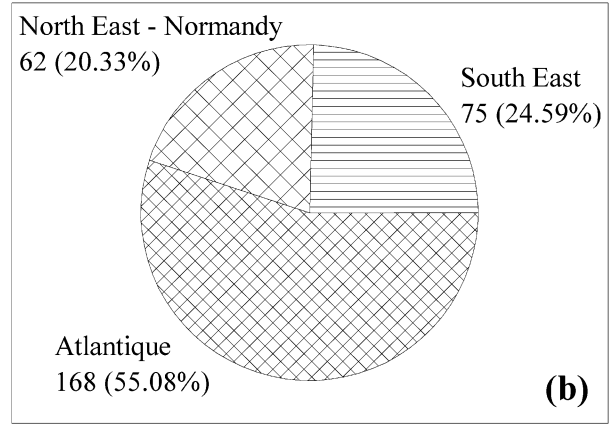
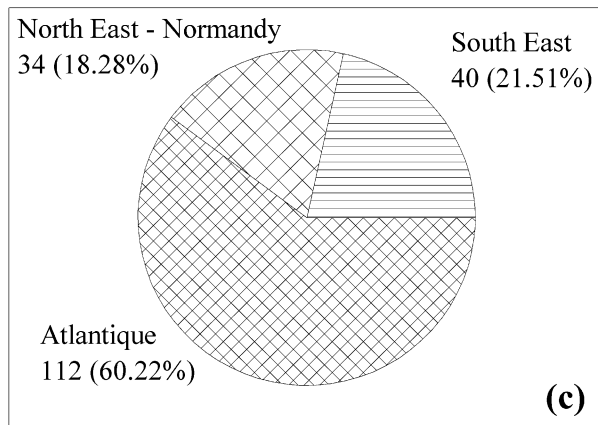
Fig. 5 depicts the problems according to the territory. Note that the French railway network is divided into three territories, each consisting of various infra-poles (sub-territory). It can be seen that *Atlantique* is the territory where there is the largest number of problems. This observation is clearer if only the sub-structure is accounted for (Fig. 5b). When considering the configuration in terms of sensitive zones (Fig. 5c), the contrast is even higher: the percentage of problems in *Atlantique* is 60% against 22% in *South-East* and 18% in *North East Normandy*. Note that *Atlantique* is the territory with a long coast of Atlantic Ocean and a large number of harbors with high frequency trading activities. However, *Atlantique* is also the territory having the highest total line length, hence a possible higher problem number.

Fig. 5: Classification of problems according to the territory. a) All problems; b) Problems related to sub-structure and c) sensitive zones

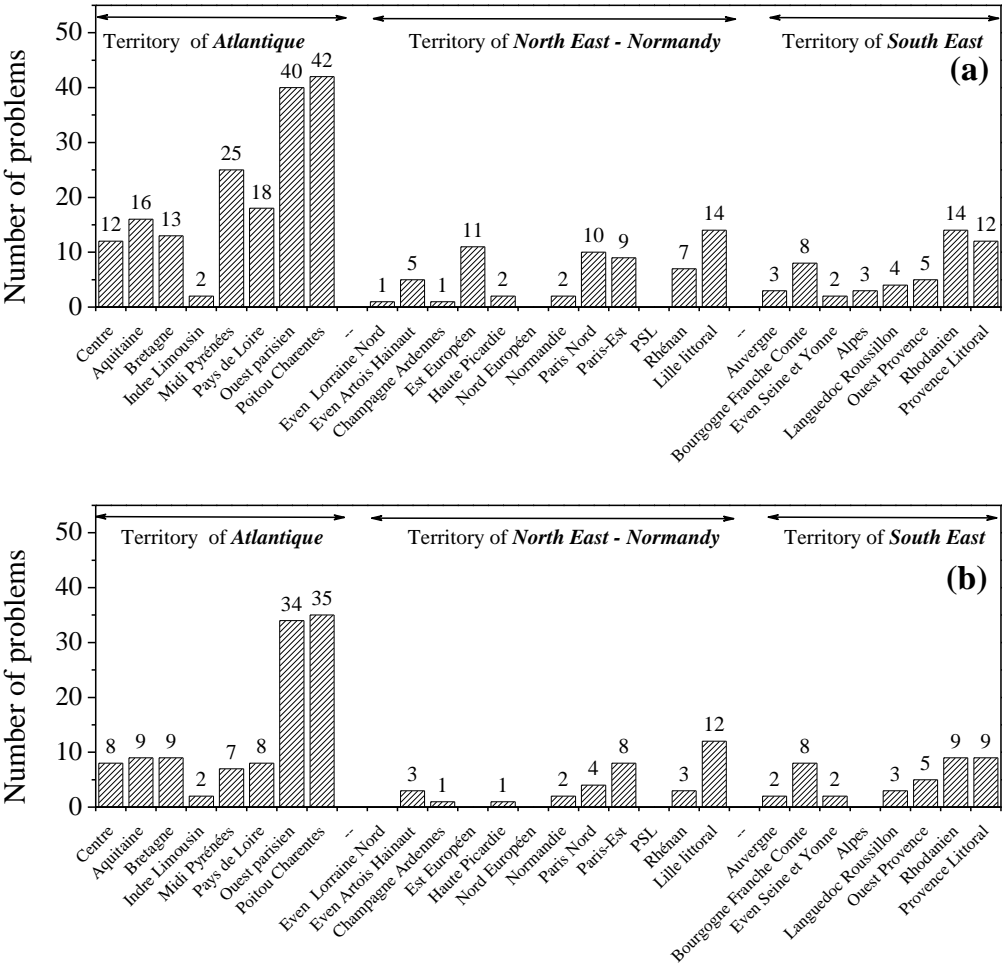
Fig. 6 shows the distribution of problems in different infra-poles. It can be observed that the problems occurred almost everywhere in France; however, most cases appeared in the infra-poles of “Ouest Parisien” (West Paris) and Poitou Charentes. Based on this observation, one line situated in the infra-pole of Poitou Charentes was selected for further in-depth investigation.

447 **Fig. 6: Classification of problems according to the Infrapole. a) Problems related to sub-structure and b) problems**
448 **related to sensitive zone**

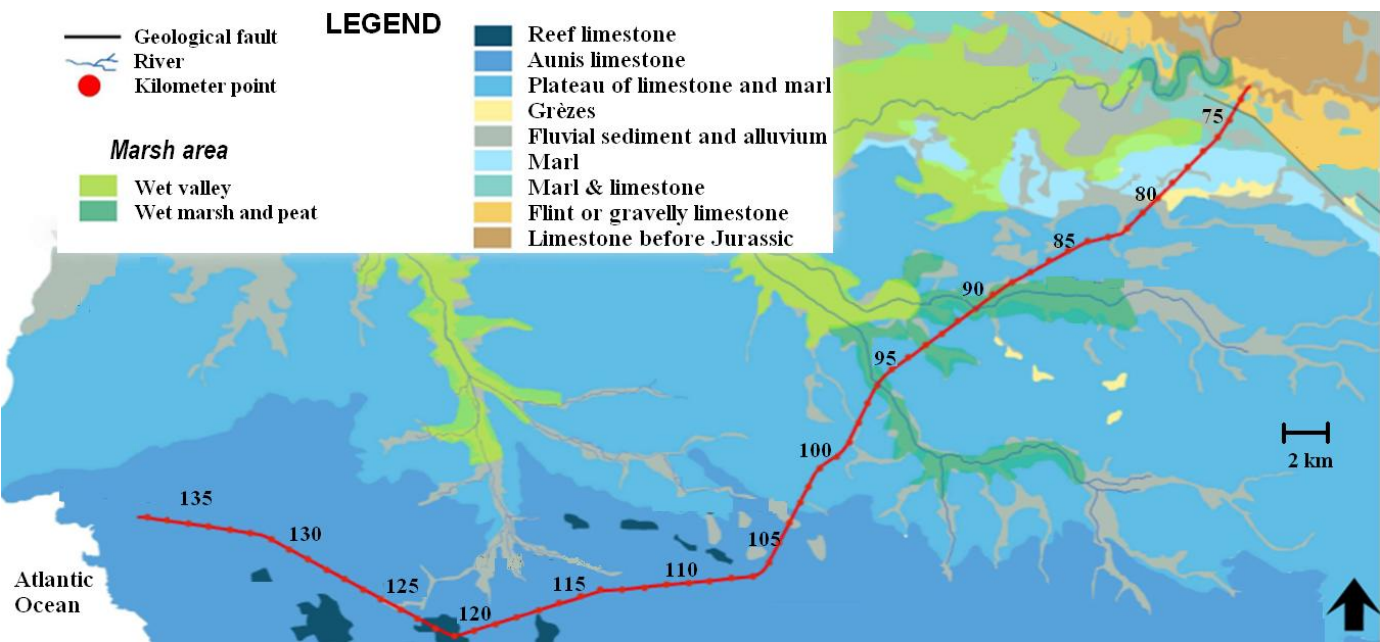
Fig. 7 presents the geological map of the studied line with the kilometer point (PK) and the geological information. The sub-grade includes five soil types. The first one at the very first kilometer of the line (from PK 74 to 75) consists of the soil of Middle Jurassic, mainly including hard limestone and marl. The thickness of each layer can vary from 10 mm to 1 m and the total thickness can reach 20 m. At PK 75, the line passes through a zone varying from river alluvial silty clay to clay-limestone. The second (from 75 to 76) involves argillaceous limestone, marl, and to a lesser extent fine alluvial deposit and peat. The thickness of these layers varies from some centimeters to 1 m. The third consists mainly of

Fig. 7: Geological map of the studied line

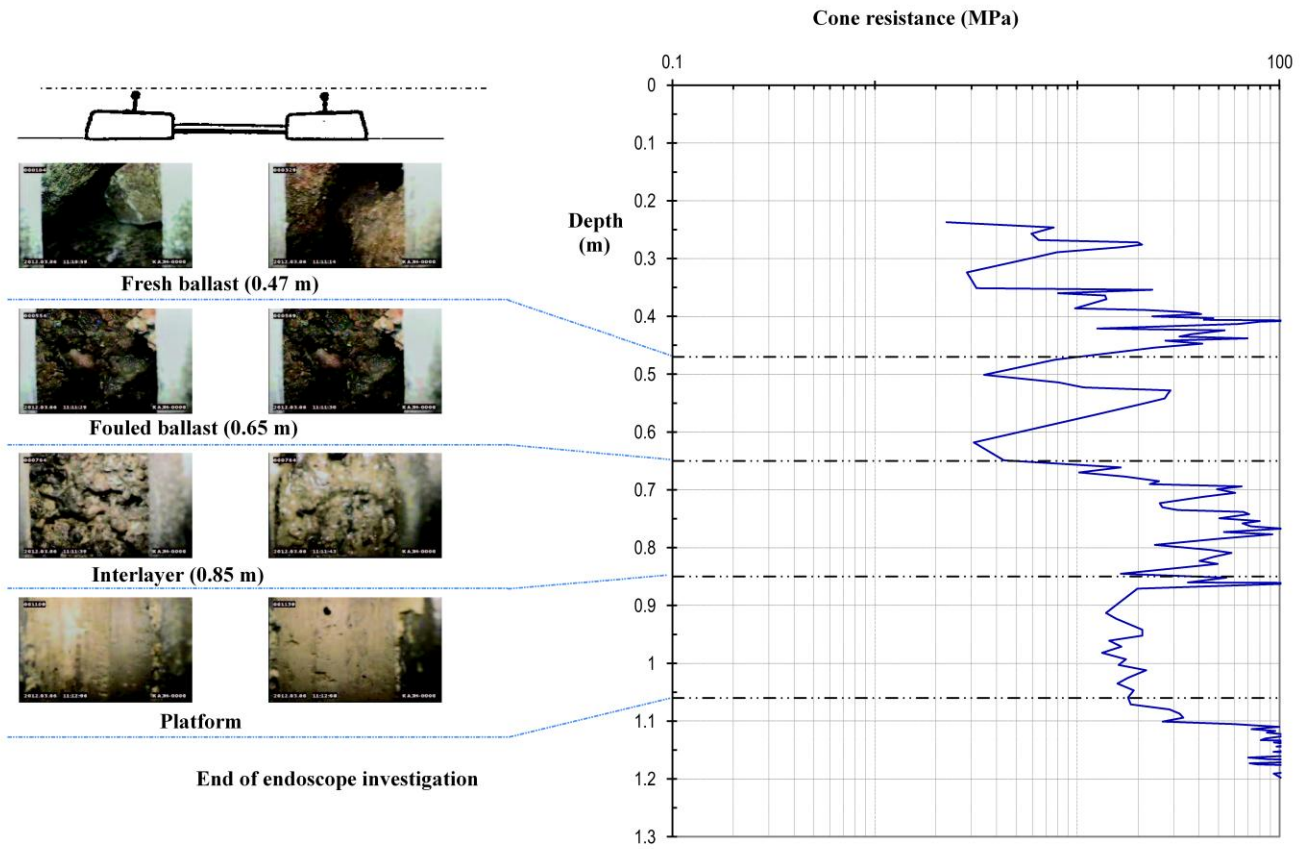
Fig. 11: Typical result from Panda and Endoscope

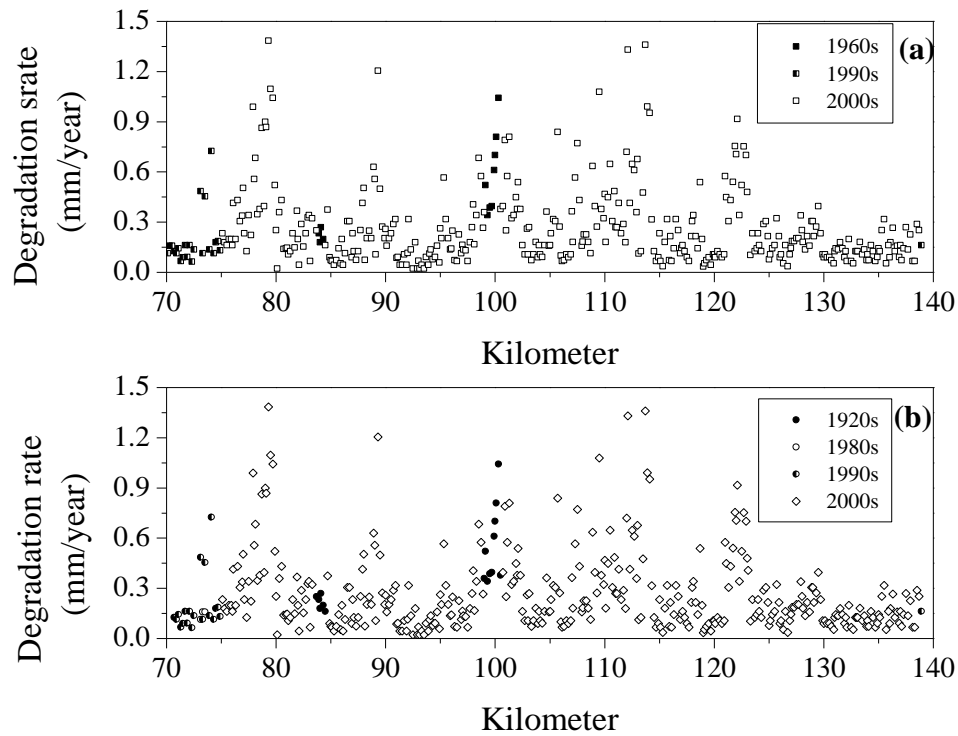
Fig. 13: Degradation rate of Track 1 according to (a) year of rail and (b) year of sleeper

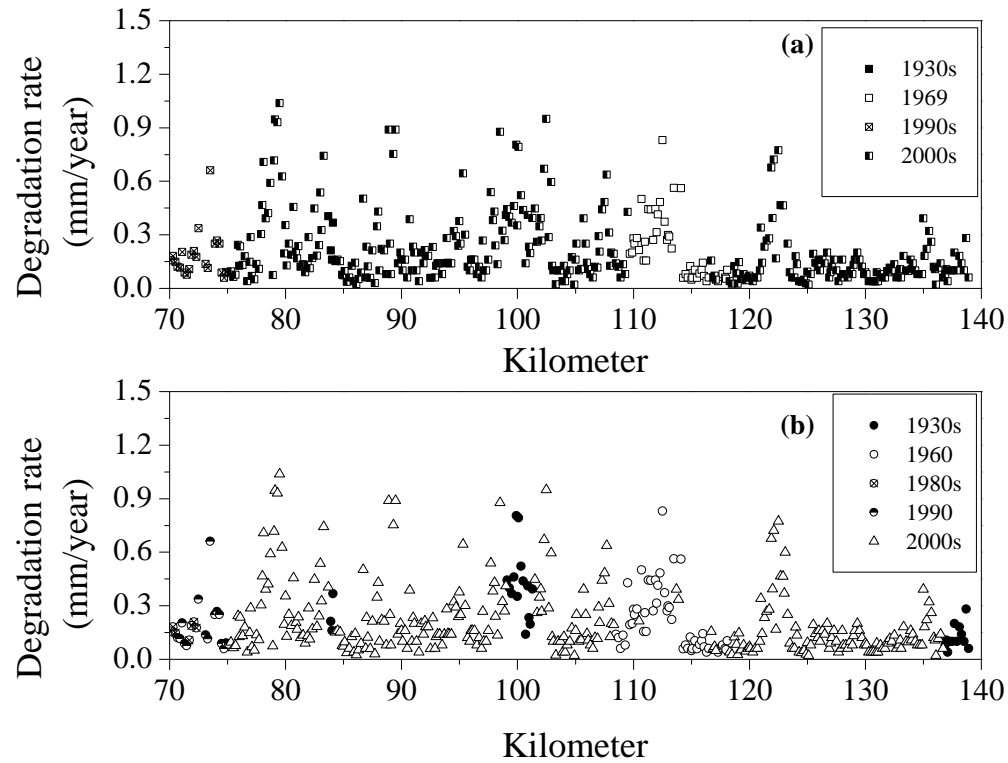
Fig. 14: Degradation rate of Track 2 according to (a) year of rail and (b) year of sleeper

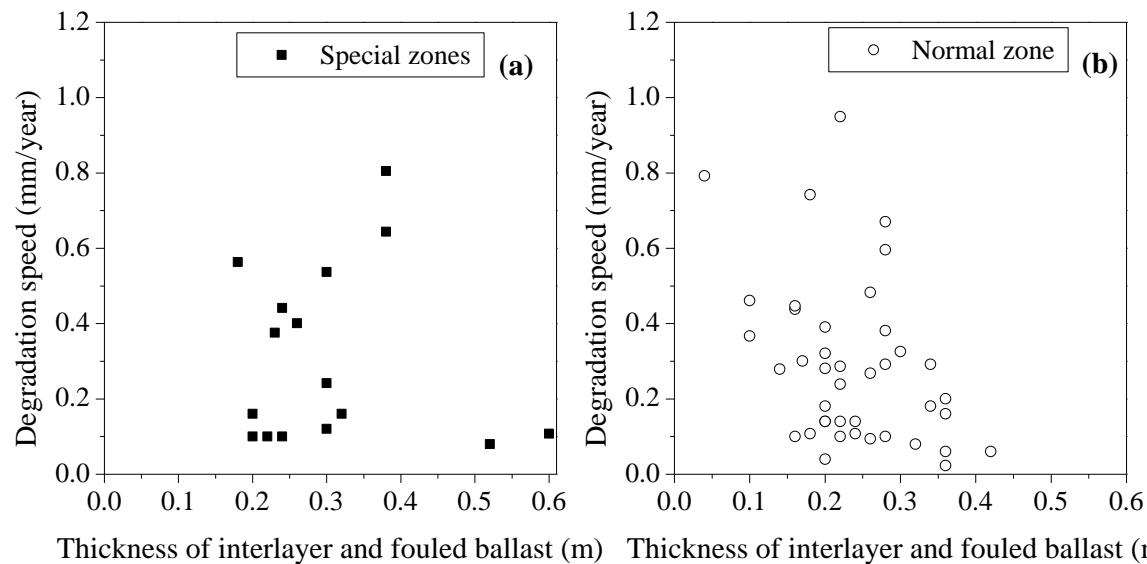
Fig. 17: Correlation of the degradation rate to the thickness of interlayer and fouled ballast for Track 2- Data from coring train. a) special zones and b) normal zone
