Durability of flax/bio-epoxy composites intended for strengthening applications in construction

DURABILITY OF FLAX/BIO-EPOXY COMPOSITES INTENDED FOR STRENGTHENING APPLICATIONS IN CONSTRUCTION

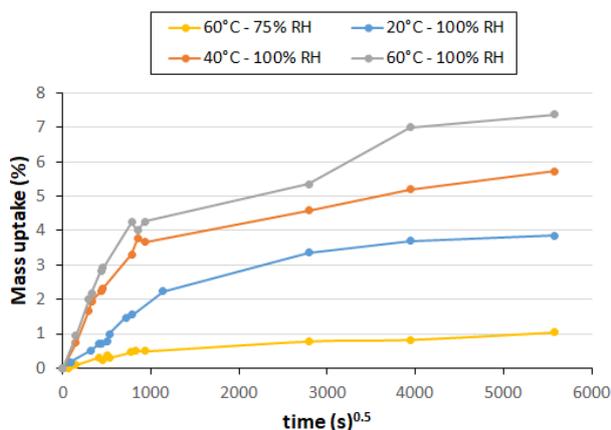
Fig. 2 shows mass uptake evolution curves over 12 months for FFRP laminates subjected to the different ageing environments, with the exception of conditions at 20°C-50% RH, 60°C-50% RH and outdoor exposure for which no significant mass change was observed.

Although sorption curves show initial linear evolutions, they do not reach a plateau at longer times and rather follow an asymptotic trend. This feature suggests that sorption process is not controlled by pure Fickian diffusion. Furthermore, as expected, humidity and temperature levels both play major roles in the sorption kinetics, as the initial slope of the curve increases significantly when one of these two factors is raised. Besides, large water uptakes are obtained with 100% RH conditions (up to 7.4% mass gain at 60°C after 12 months ageing). This result shows that FFRPs are prone to extensive water ingress when exposed to moist or wet environments. Water absorption may thus be a driving factor in the degradation of the mechanical performances of both the laminate and its adhesive bond with concrete during wet ageing. This point will be investigated in the next sections.

Fig. 2: Mass uptake versus $(time)^{0.5}$ for FFRP laminates subjected to the various ageing conditions.

Water sorption kinetics was linked to the humidity level of the ageing environment and was also found to be accelerated by temperature. Micrographic observations showed significant swelling of the flax fibers for specimens immersed at 20°C compared to reference samples, but contrarily, a reduction of the fiber section was noticed after immersion at 40 and 60°C, suggesting an alteration of the internal structure of flax fibers. Anyway, large water ingress observed under immersion at elevated temperature was assigned to the sorption process within the bio-epoxy matrix and interfacial areas, and to micro-cracking of the matrix entrapped in fiber bundles, as revealed by X-ray tomography.

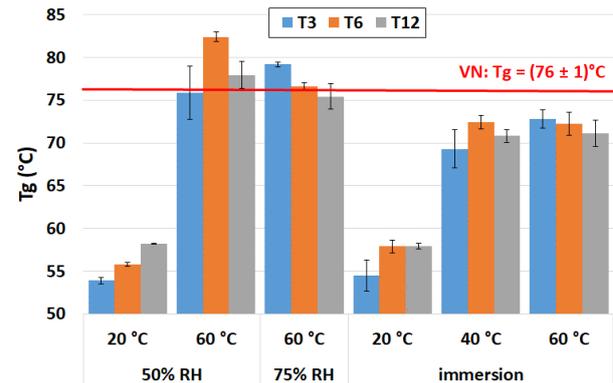
Fig. 3. reports values of the glass transition temperature (T_g) measured by DSC on FFRP laminates aged in the various environments for periods of 3, 6 and 12 months.

T_g of the specimen exposed to weathering conditions (VN) for 12 months is depicted by the red line.

Fig. 3: T_g of FFRP laminates after exposure from 3 to 12 months (T_3 to T_{12}) in the various ageing conditions. Red line corresponds to T_g level after 12 months outdoor exposure (VN).

Reference T_g value measured for the unaged laminate cured for 3 weeks at room temperature was $55.0 \pm 0.5^\circ\text{C}$. Such a low T_g is characteristic of an under-cured state of the polymer matrix, in which the polymerization process didn't reach completion.

From Fig. 3, it is found that T_g of the specimen aged at 20°C under moderate humidity (50% RH) increases slowly over time, without overpassing 58°C after 12 months. This is due to the very slow reaction kinetics of residual monomers at this temperature. A similar trend is observed at 20°C under immersion, for the same reason.

Exposure to 60°C under moderate humidity (50% RH) leads first to a very large increase in T_g during the first 6 months (up to 82°C), followed by a slight decrease over the next 6 months. The first increase can be assigned to the post-curing process of the polymer matrix, as the elevated temperature facilitates the diffusion of unreacted monomers and promotes further crosslinking of the thermoset network. In the second stage, the decay may result from oxidation induced degradation (to be confirmed by FTIR analyses).

Ageing at 60°C and 75% RH leads also to a sharp increase in T_g during the first 3 months, followed by a decay after 6 and 12 months, which may relate to the effect of humidity through a plasticization process. Oxidation-induced degradation may also be involved at long ageing times.

Regarding samples immersed in water (100% RH) at elevated temperatures (40 and 60°C), an initial T_g increase is also observed during the first 3 months due to post-cure (the higher the ageing temperature, the higher this T_g increase). However, such an increase remains limited compared to that obtained at 60°C under moderate or intermediate humidity levels (50 and 75% RH). This result suggests that, under wet environment, the evolution of T_g may be controlled by both the post-cure process and the plasticization by water, which have opposite effects on T_g [14-16]. At longer times (12 months at 40°C and 6 months at 60°C), a decreasing variation of T_g is observed again, suggesting that plasticization effect becomes predominant.

A very interesting feature is that T_g measured on specimens exposed for 12 months to outdoor conditions is about 76°C (very close to T_g value obtained after 12

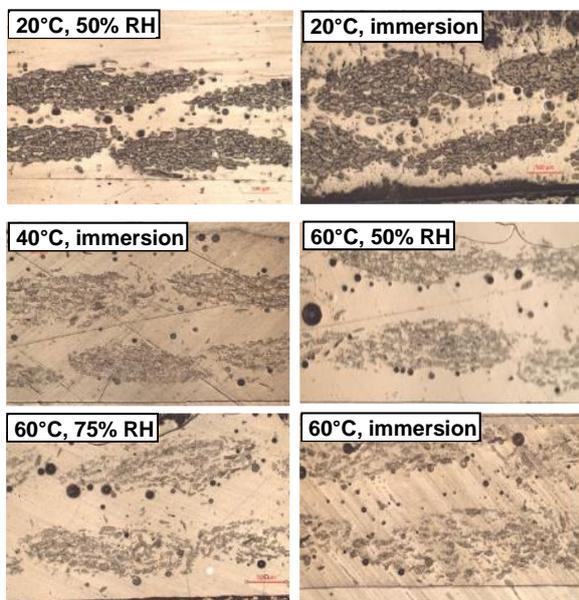
Fig. 4 displays pictures of specimens aged for 3 months in the various environments. Two main features are revealed by these images:

- First, a variation of the apparent section of flax fibers can be noticed, depending on the ageing conditions. An increase in the fiber section is observed for laminates subjected to 20°C in immersion compared to those stored at 20°C-50% RH, which can be assigned to the swelling of flax fibers induced by water absorption. Differently, specimens exposed to elevated temperatures show reduced fiber sections compared to those stored at 20°C, whatever the level of relative humidity. This may result from a modification of the fiber structure, which is not clearly identified at this stage (collapse of the internal hollow structure, extraction of soluble components?). Nevertheless, it suggests that for FFRP composites immersed at high temperature, the extensive sorption process evidenced in Fig. 2 results from water absorption by the polymer matrix and interfacial areas, and not by the fibers themselves.

- Besides, lightening and change of colour of the flax fibers (which turns to light honey colour) are observed for FFRP laminates exposed to high temperatures.

Fig. 4: Microscopic observations of polished cross-sections of FFRP laminates after being subjected to various ageing conditions for 3 months.

Regarding the evolution of the tensile Young's modulus (Fig. 5), the increase in humidity is found to degrade significantly the longitudinal stiffness of the FRP laminates over ageing. This effect is usually accompanied by an increase in ultimate elongation. For immersed specimens, the drop of modulus can reach up to 40% after 12 months at 60°C-100% RH. Such phenomena can be assigned to a plasticization effect induced by water on the polymer matrix, and to degradations (cracks) occurring within the matrix and at fiber/matrix interfaces due to swelling of the polymer and alteration of the fiber sections, as shown previously in Figs. 4 and 5.

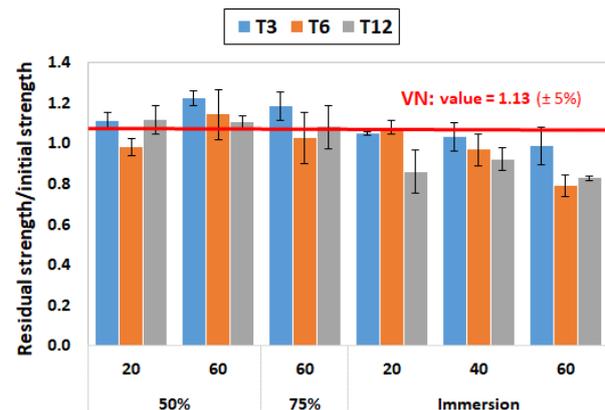
Fig. 4 and Fig. 5 report the normalized residual tensile properties (residual strength and modulus, respectively) obtained for FFRP laminates subjected to ageing periods up to 12 months in the various environments.

Fig. 4: Normalized residual strengths of specimens that were exposed to the various ageing conditions for periods up to 12 months. (T3, T6 and T12). The red line shows the value of the specimen exposed to weathering conditions (VN) for 12 months.

Regarding the tensile strength (Fig. 4), FRP composites didn't show any degradation after 3 months ageing, and a significant increase was even observed for specimens exposed to the temperature of 60°C at 50% and 75% RH, which was explained by the post-curing process of the bio epoxy matrix as previously evidenced by DSC analyses. Between 3 and 12 months ageing, specimens immersed in water show a 20% reduction of their residual strength, with a kinetics that is dependent on ageing temperature (the higher the temperature, the higher the degradation kinetics). This feature can be correlated to the water sorption kinetics, which is also temperature dependent as shown previously in section 3.1.

Specimens exposed to outdoor conditions for 12 months exhibit a slight increase in tensile strength compared to the reference, probably due to the post-cure effect evidenced by DSC.

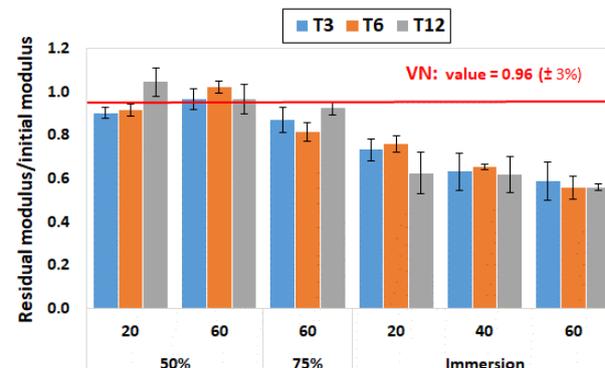
Fig. 5: Normalized residual modulus of specimens that were exposed to the various ageing conditions for periods up to 12 months (T3, T6 and T12). The red line shows the value of the specimen exposed to weathering conditions (VN) for 12 months.

An interesting point is that natural ageing (12 months exposure to outdoor conditions) does not affect the stiffness of the FRP laminate significantly, differently from what is observed with accelerated ageing tests, especially under immersion. This result suggests that immersion conditions are very severe compared to natural ageing.

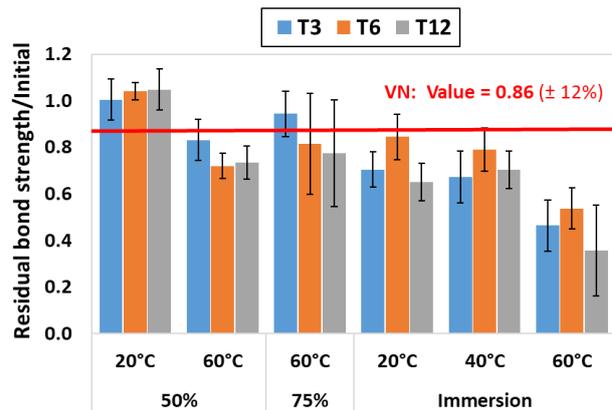
Residual pull-off strength determined on specimens aged in the various accelerated conditions over periods from 3 to 12 months (T3 to T12) are then displayed in Fig. 6. Values are normalized by the reference value, i.e. the mean pull-off strength of unaged specimens.

Fig. 6: Normalized residual bond strength between FRPs and concrete after exposure to the various ageing conditions for periods up to 12 months. The red line shows the value of the specimen exposed to weathering conditions (VN) for 12 months.

A significant decrease in bond strength was observed for all specimens, with the exception of those stored at 20°C-50% RH. Moreover, samples directly immersed in water were the most affected, with a reduction up to 50% in the case of samples subjected to 60°C-100% RH, which is also consistent with the large water uptake evidenced for FRP composites in these conditions (Fig. 2). Such a degradation of the bond strength under wet conditions was accompanied by a change in failure mode, from an initial cohesive concrete failure towards a mixed failure mode (Fig. 7b) or FRP debonding mode (Fig. 7c) after ageing. This change in failure mode and the reduction in bond strength can both be attributed to a weakening of physico-chemical bonds at the concrete/composite interface in presence of water.

Here again, a very interesting feature is that specimens aged under natural weathering conditions (VN) for 12 months show only limited reduction of their pull-off

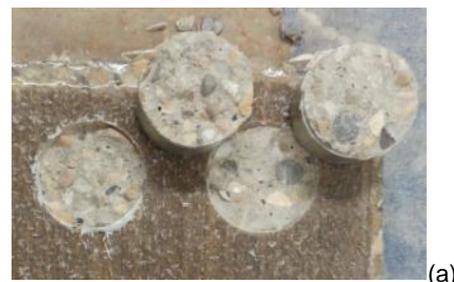
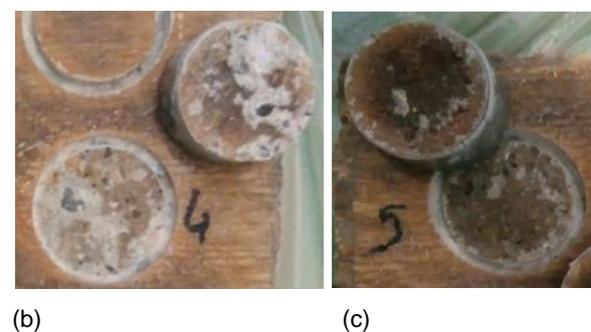
Fig. 7: Failure modes after pull-off tests - (a) initial cohesive concrete failure on unaged specimens, (b) typical mixed failure and (c) composite debonding obtained for specimens subjected to wet ageing.

Adhesive bond properties were assessed by pull-off tests. In a preliminary stage, reference properties were determined on unaged FRP strengthened concrete slabs, giving an average value of 4.09 ± 0.25 MPa for the pull-off strength and a typical cohesive concrete failure (Fig. 7.a).

strength (~14%), together with a mixed failure mode similar to that presented in Fig. 7.b. This suggests once more that natural ageing might be less severe compared to accelerated ageing by immersion in water.
